Lake Atalanta Park Restoration  
Water Conservation Features: Gravel-Pave

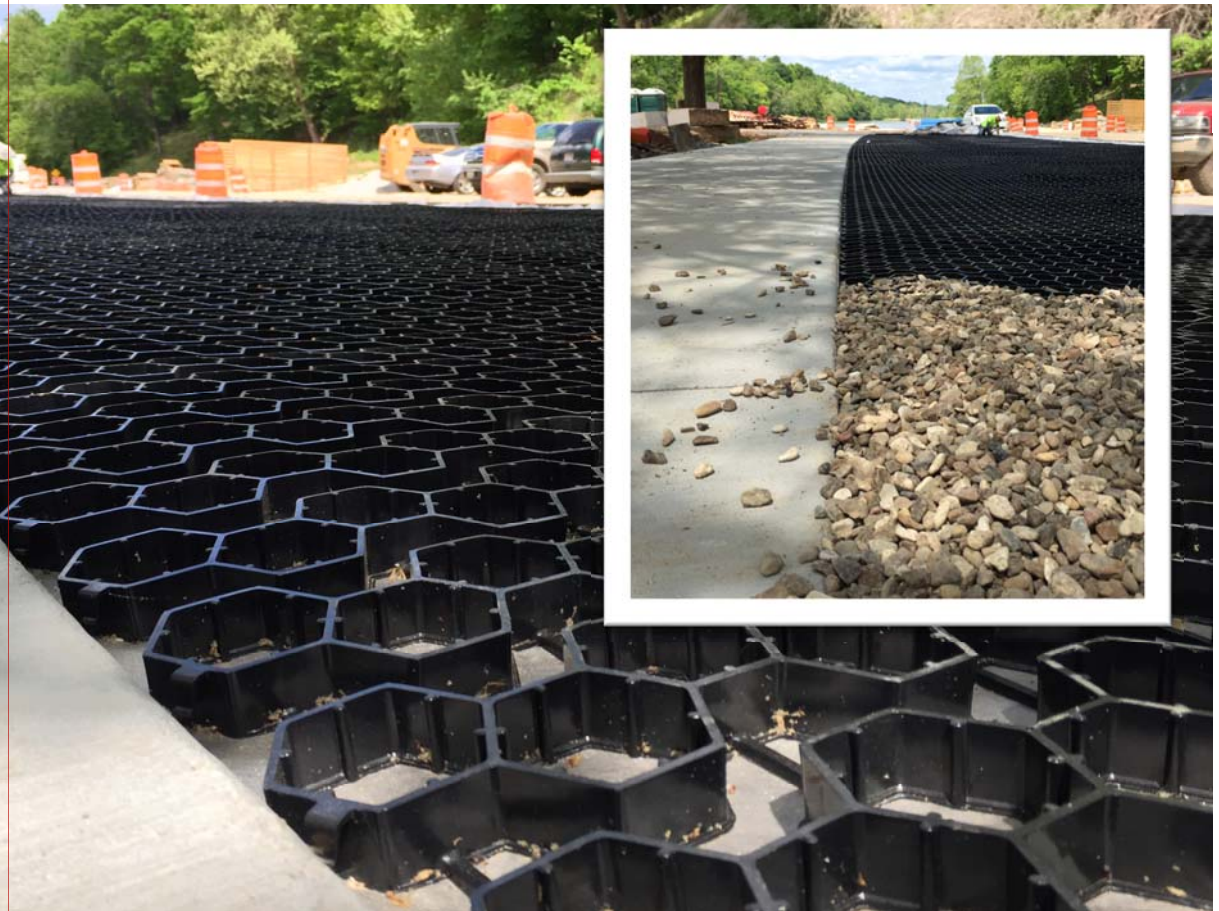
Over 6,750 square feet of *gravel-pave* parking areas at the newly renovated Lake Atalanta Park allows rainwater to infiltrate and soak down through the underlying gravel and soil. The soil acts as a filter to remove contaminants through natural bacterial action and chemical processes. Underlying gravel layers, composed of coarse, angular stone, allow for water passage while still providing a stable surface for parking. The gravel surface is held in place by a recycled plastic structural layer that is strong enough to drive and park on.

This project is an example of *Low Impact Development* and helps reduce negative impacts of traffic-borne contaminants at Lake Atalanta Park by allowing the rainwater to soak into gravel and soil rather than wash directly into Prairie Creek which flows into Beaver Lake.
